# **Debris/Ice/TPS Assessment and Integrated Photographic Analysis of Shuttle Mission STS-90**

*Gregory N. Katnik  
Process Engineering/Mechanical System Division/ET-SRB Branch,  
Kennedy Space Center, Florida*

**17 April 1998**

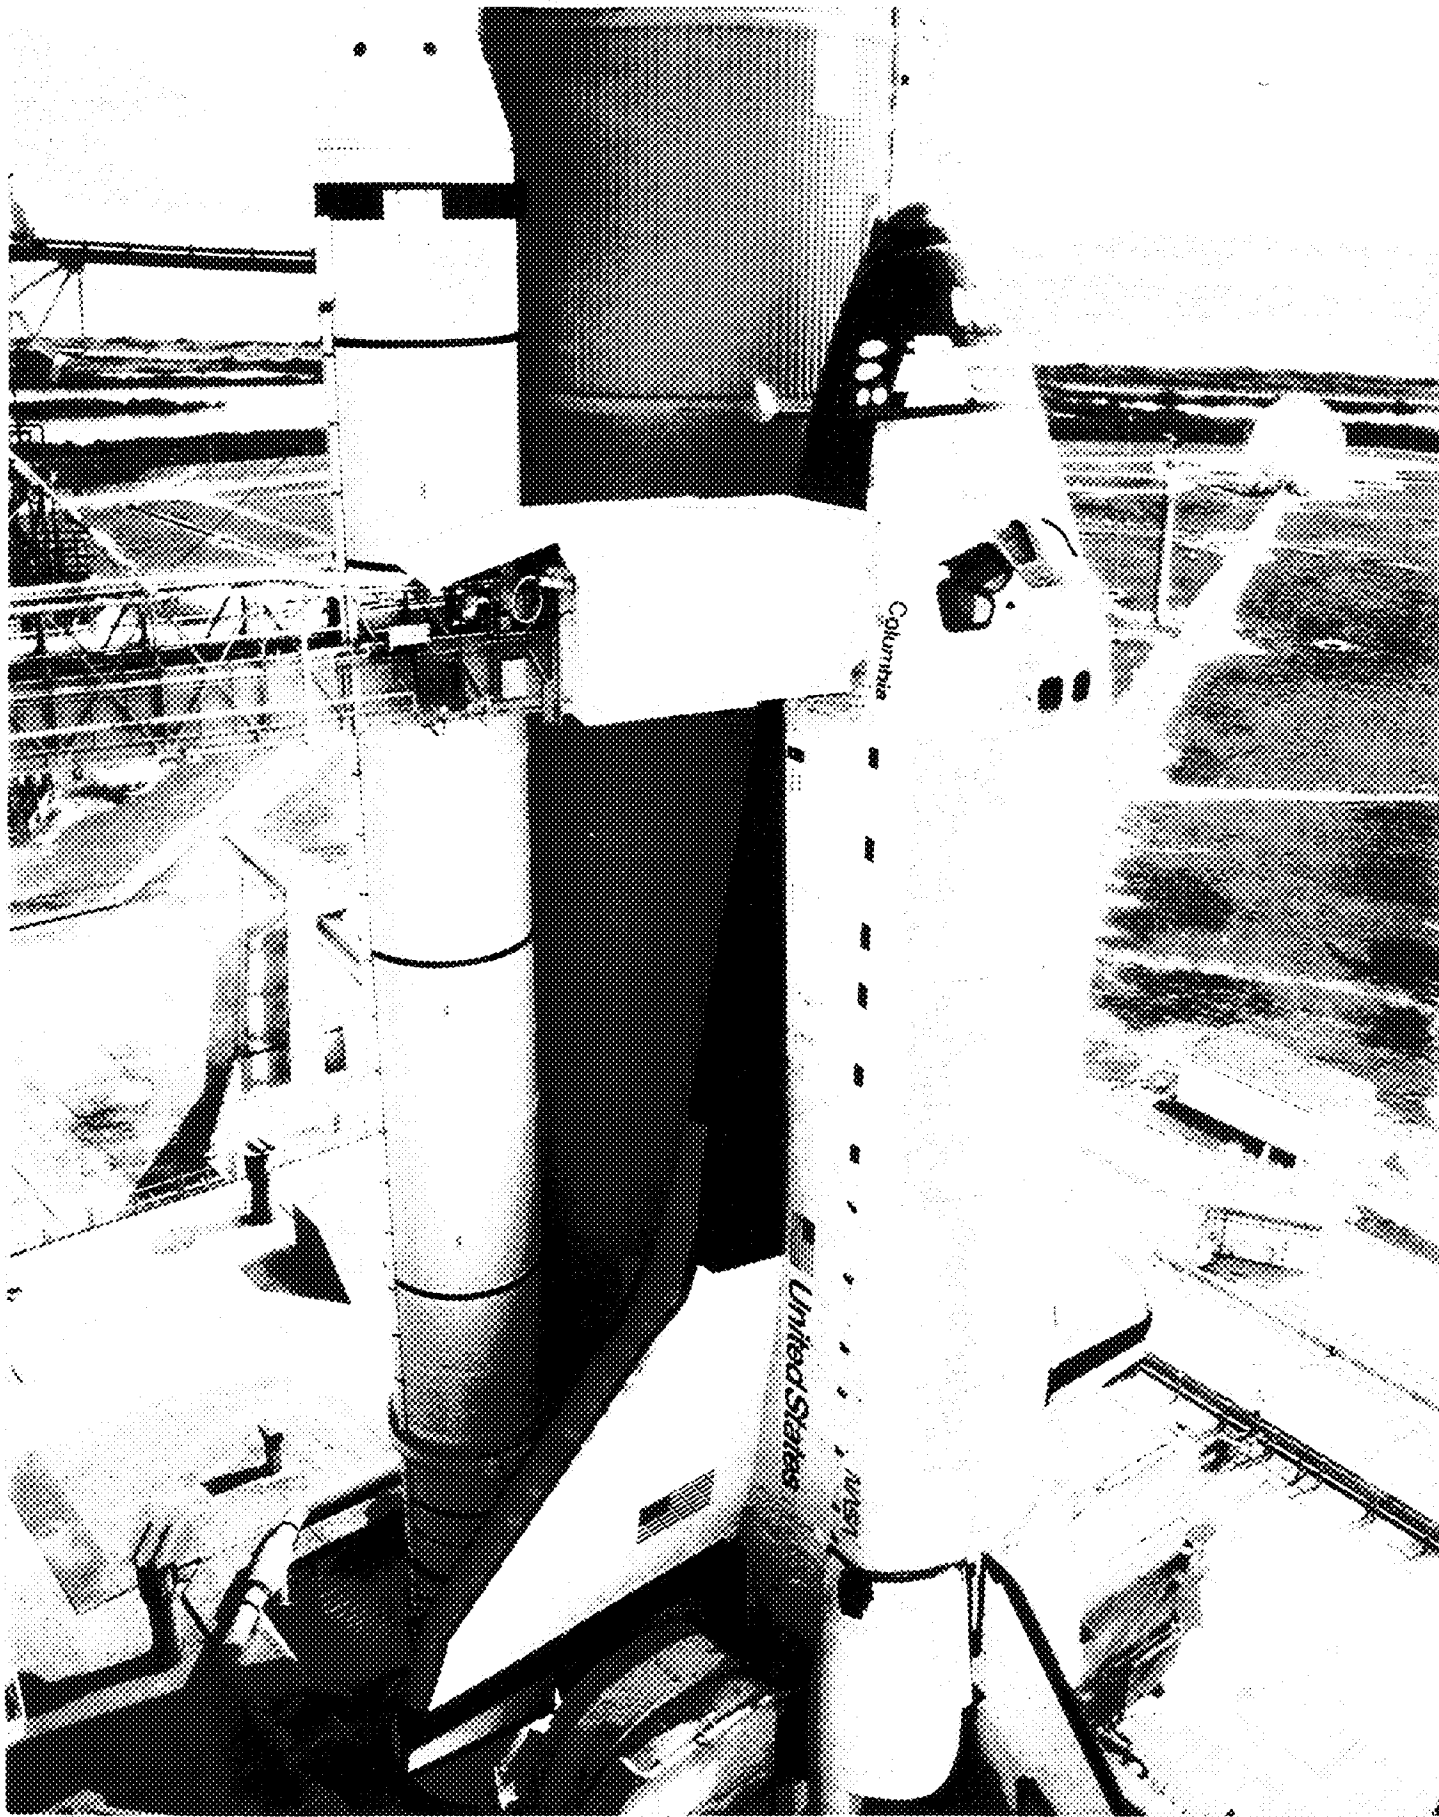
**Photo 3: LH2 Tank After Cryoload**

The Final Inspection Team detected no ice, frost, or condensate on the LH2 tank acreage. TPS surface temperatures averaged 67 degrees F on the +Z side and 63 degrees F on the -Z side. Note configuration change to the intertank, which had been machined/sanded.

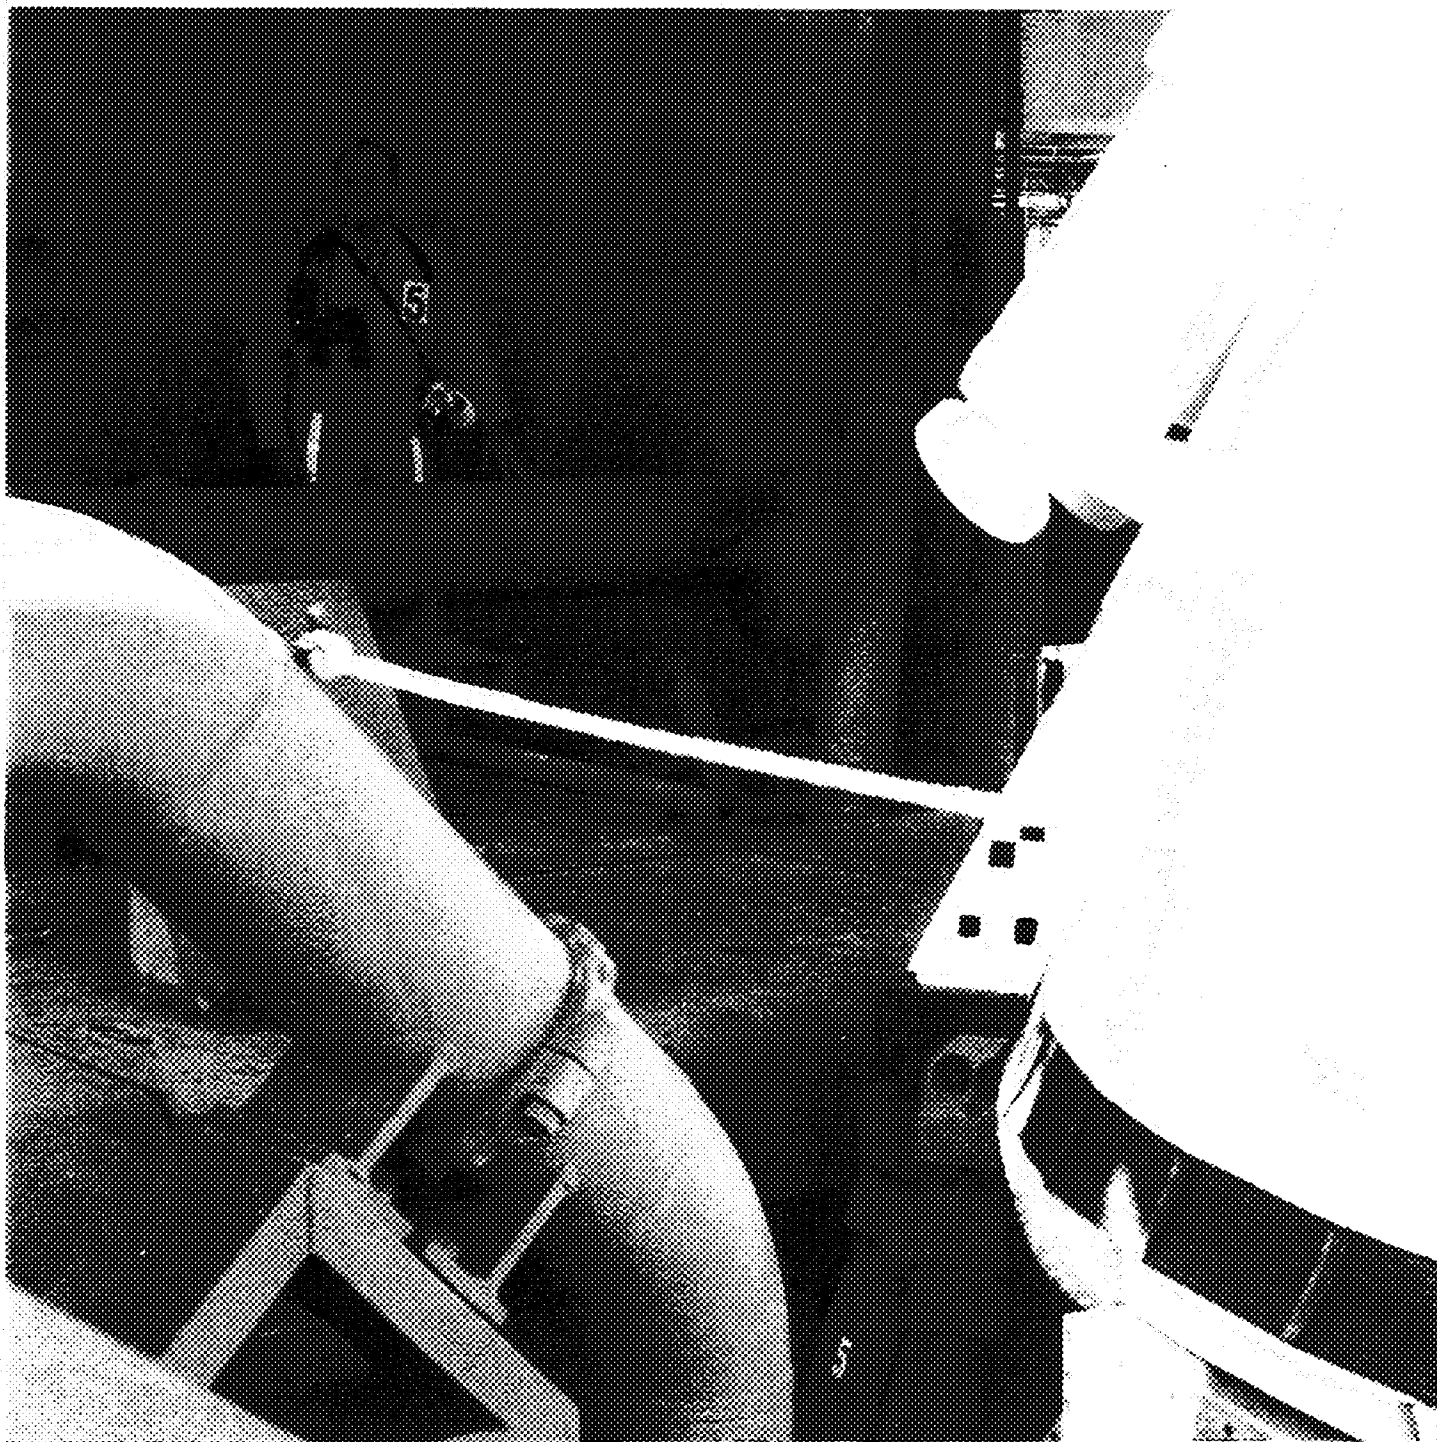
**Photo 7: Debris Items on MLP Deck**

Three debris items were found on the MLP deck directly below the External Tank. A 3/4-inch diameter personnel safety life line was tied between two sound suppression water pipes adjacent to holddown posts #5 and #7. A white, plastic, heavy duty tie-wrap was on the 8-inch sound suppression water pipe adjacent to holddown post #1. And a broken drill bit 1-inch long by 1/4-inch diameter lay on the MLP deck.

Three debris items were found on the MLP deck directly below the External Tank. A  $\frac{3}{4}$ -inch diameter personnel safety life line was tied between two sound suppression water pipes adjacent to holddown posts #5 and #7 (above). A white, plastic, heavy duty tie-wrap was on the 8-inch sound suppression water pipe adjacent to holddown post #1. And a broken drill bit 1-inch long by  $\frac{1}{4}$ -inch diameter lay on the MLP deck.

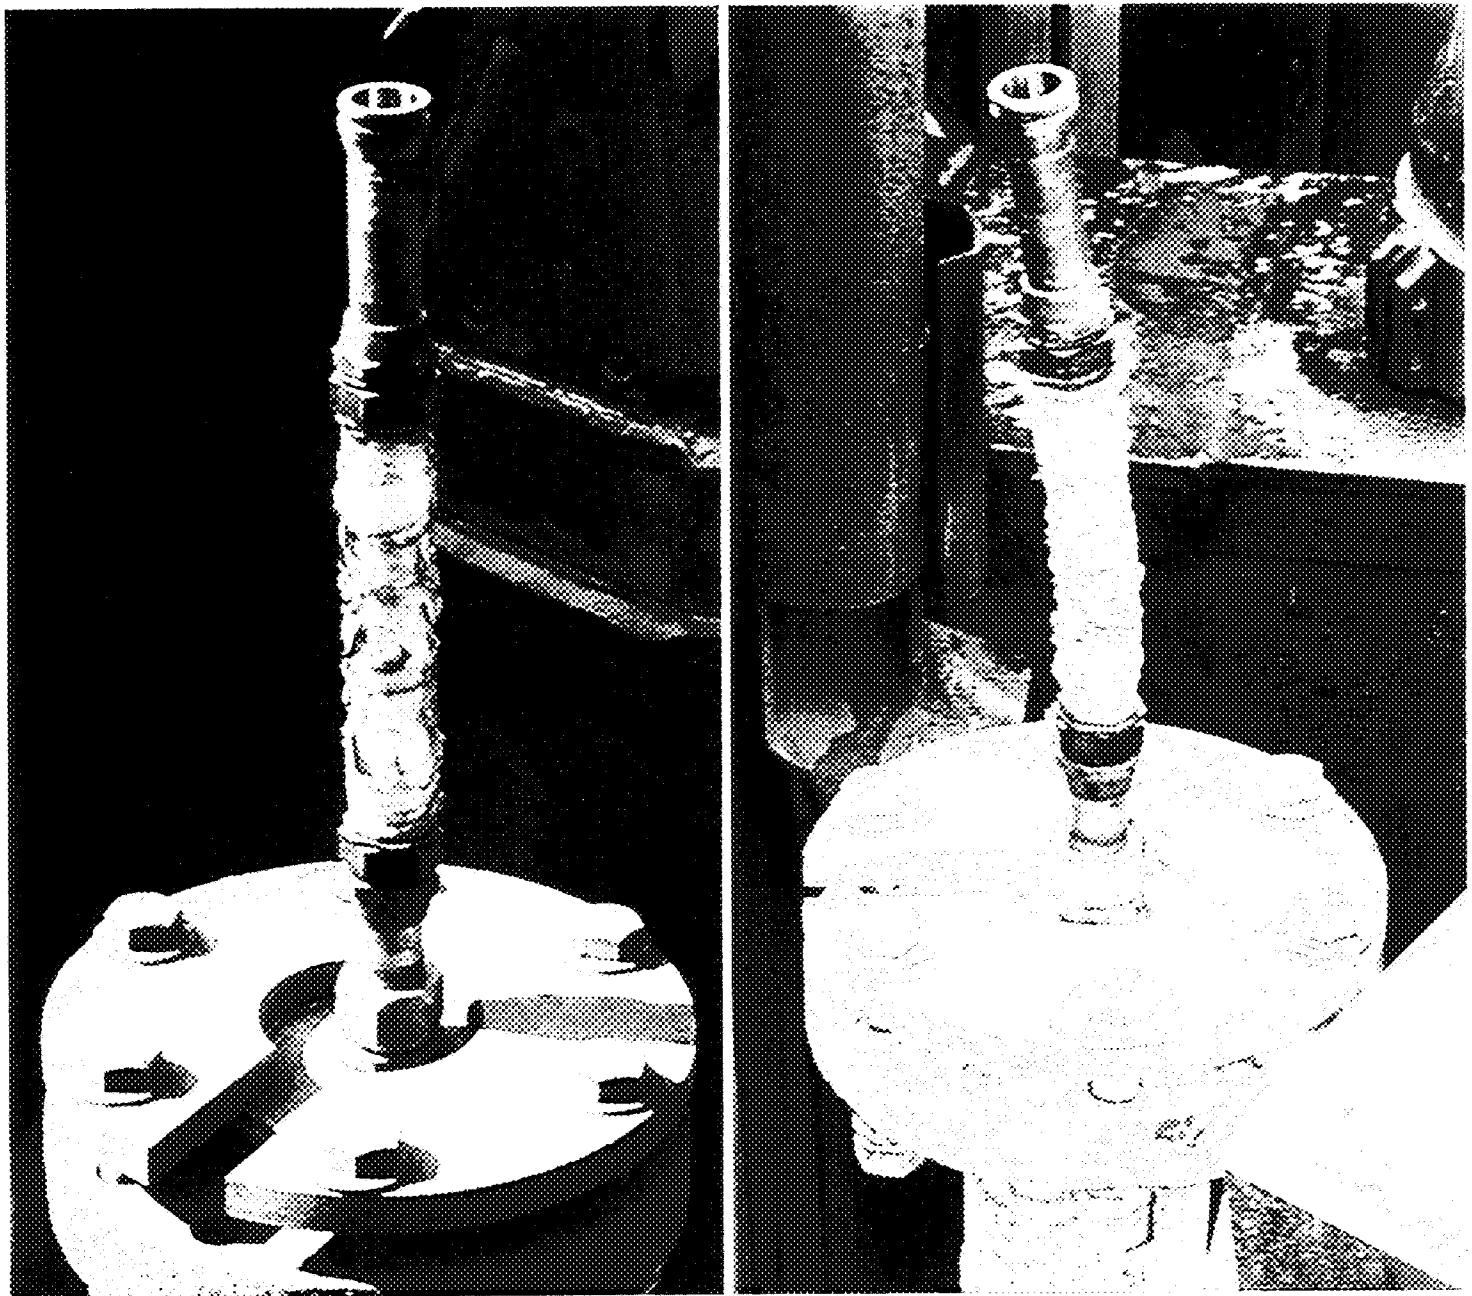
**Photo 8: SRB Aft Skirt GN2 Purge Lines**

Both right and left SRB aft skirt GN2 purge lines were intact after liftoff. The first layer of protective aluminum tape had eroded away. The remaining two layers probably kept the steel braid and internal tube from melting, a common failure mode on previous launches.

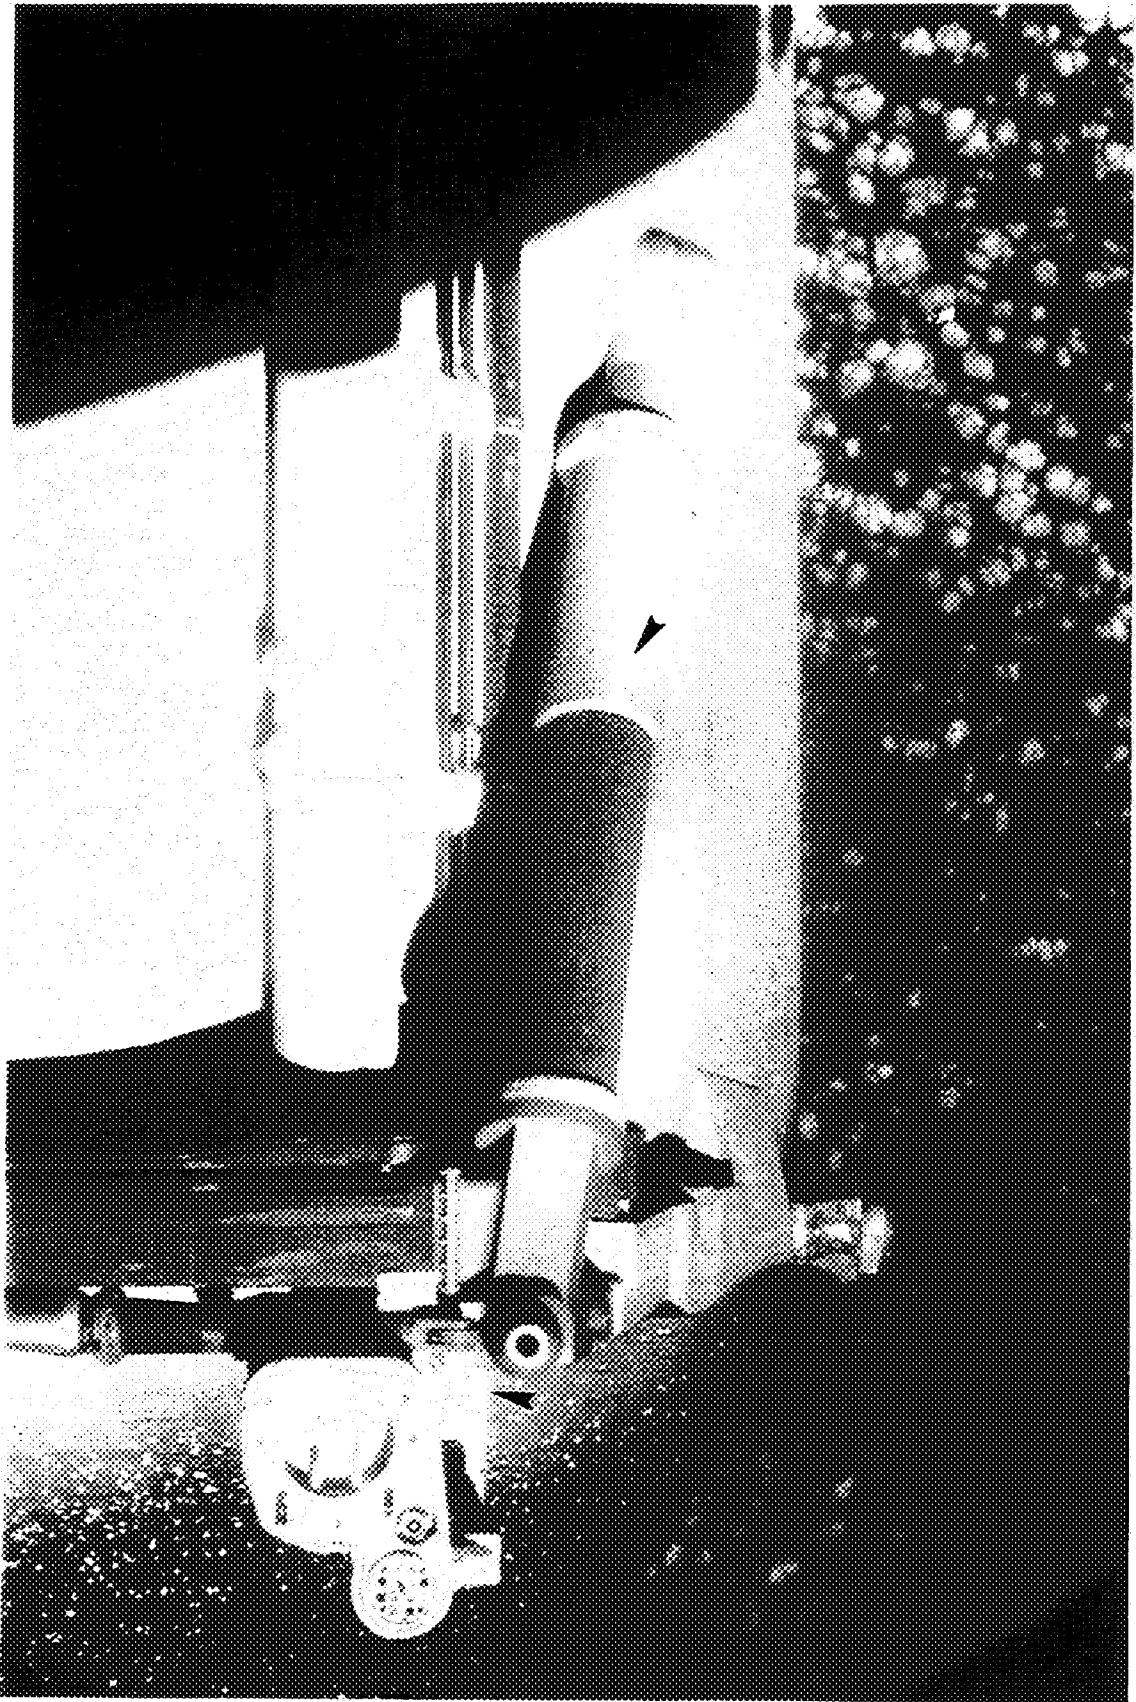
**Photo 13: LO2 ET/ORB Umbilical**

The LO2 ET/ORB umbilical cable tray exhibited typical erosion and divoting. The umbilical itself was undamaged. A long gash in the +Y thrust strut TPS was most likely caused by a debris impact. Note small, shallow “popcorn” type divots on the aft dome and LH2 tank acreage - a typical occurrence. Also note the charring and flaking off of a thin layer of foam from the +Y upper strut fairing closeout.

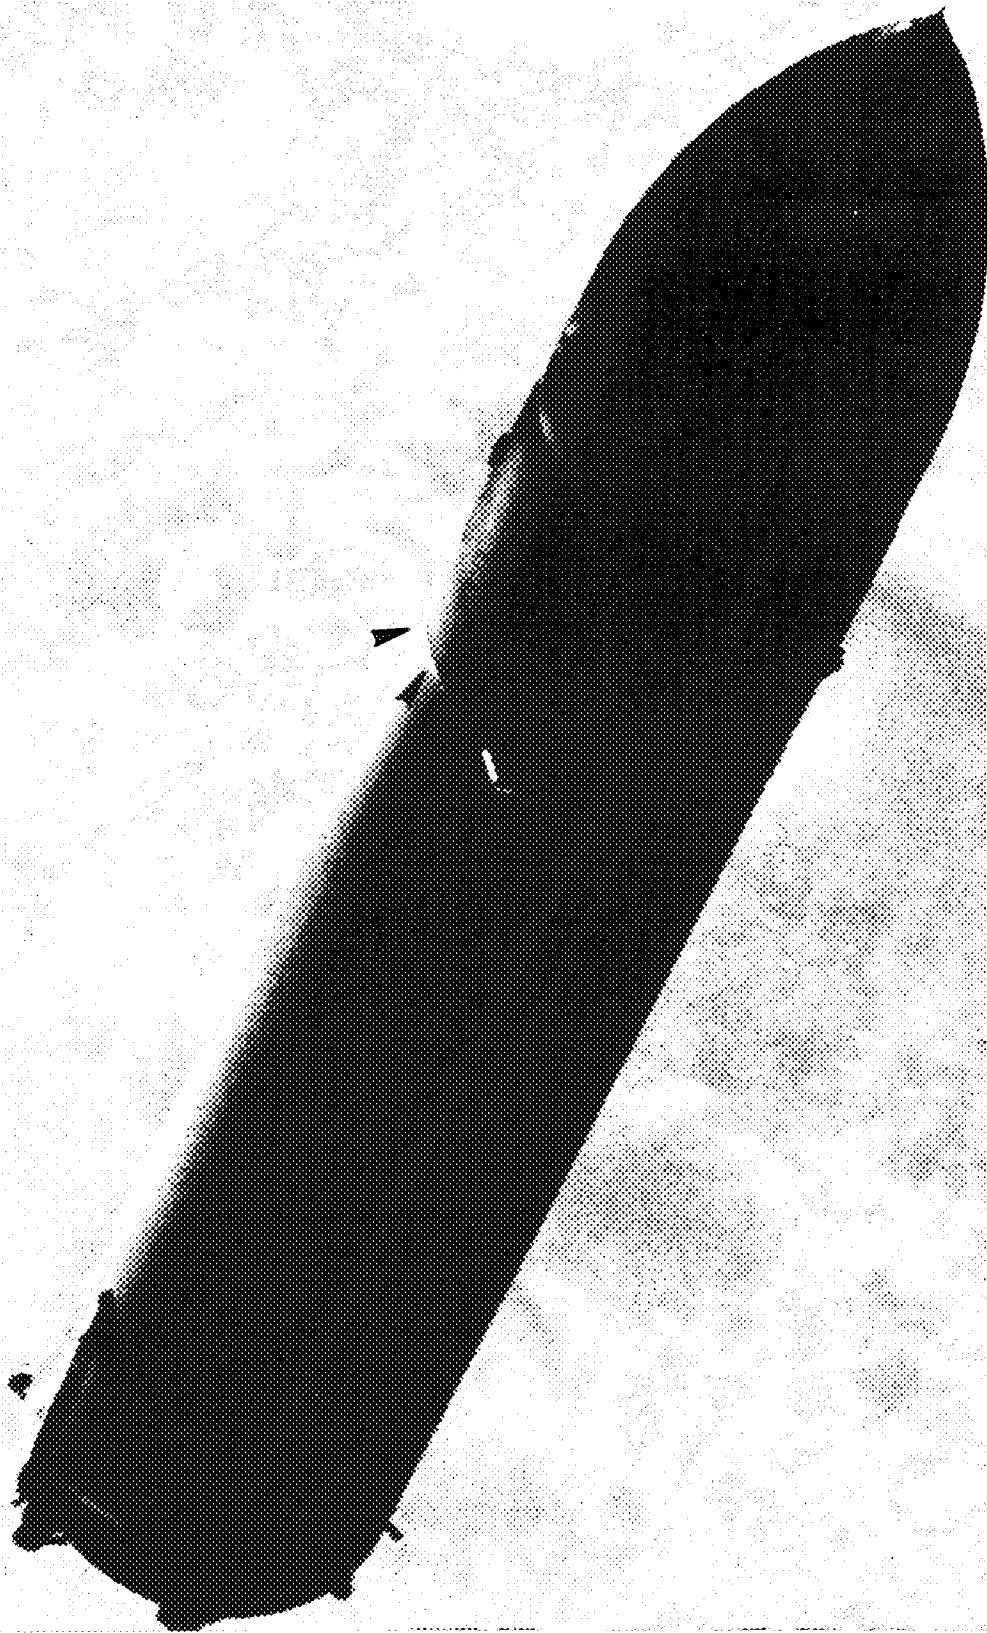
**Photo 15: Intertank**

The +Z side of the intertank appeared to be in good condition. Heating from the shock waves off both forward EB fittings left black marks on the intertank acreage in a line from the EB fittings to the bipod spindle housings. These marks have not been so pronounced on previous tanks and may be more visible due to the sanded foam acreage.

The +Z side of the intertank appeared to be in good condition. Heating from the shock waves off both forward EB fittings left black marks on the intertank acreage in a line from the EB fittings to the bipod spindle housings. These marks have not been so pronounced on previous tanks and may be more visible due to the sanded foam acreage. Three divots (two 4-6 inches in diameter and one approximately 10-inches in diameter) were visible in the flange closeout -Y+Z quadrant.

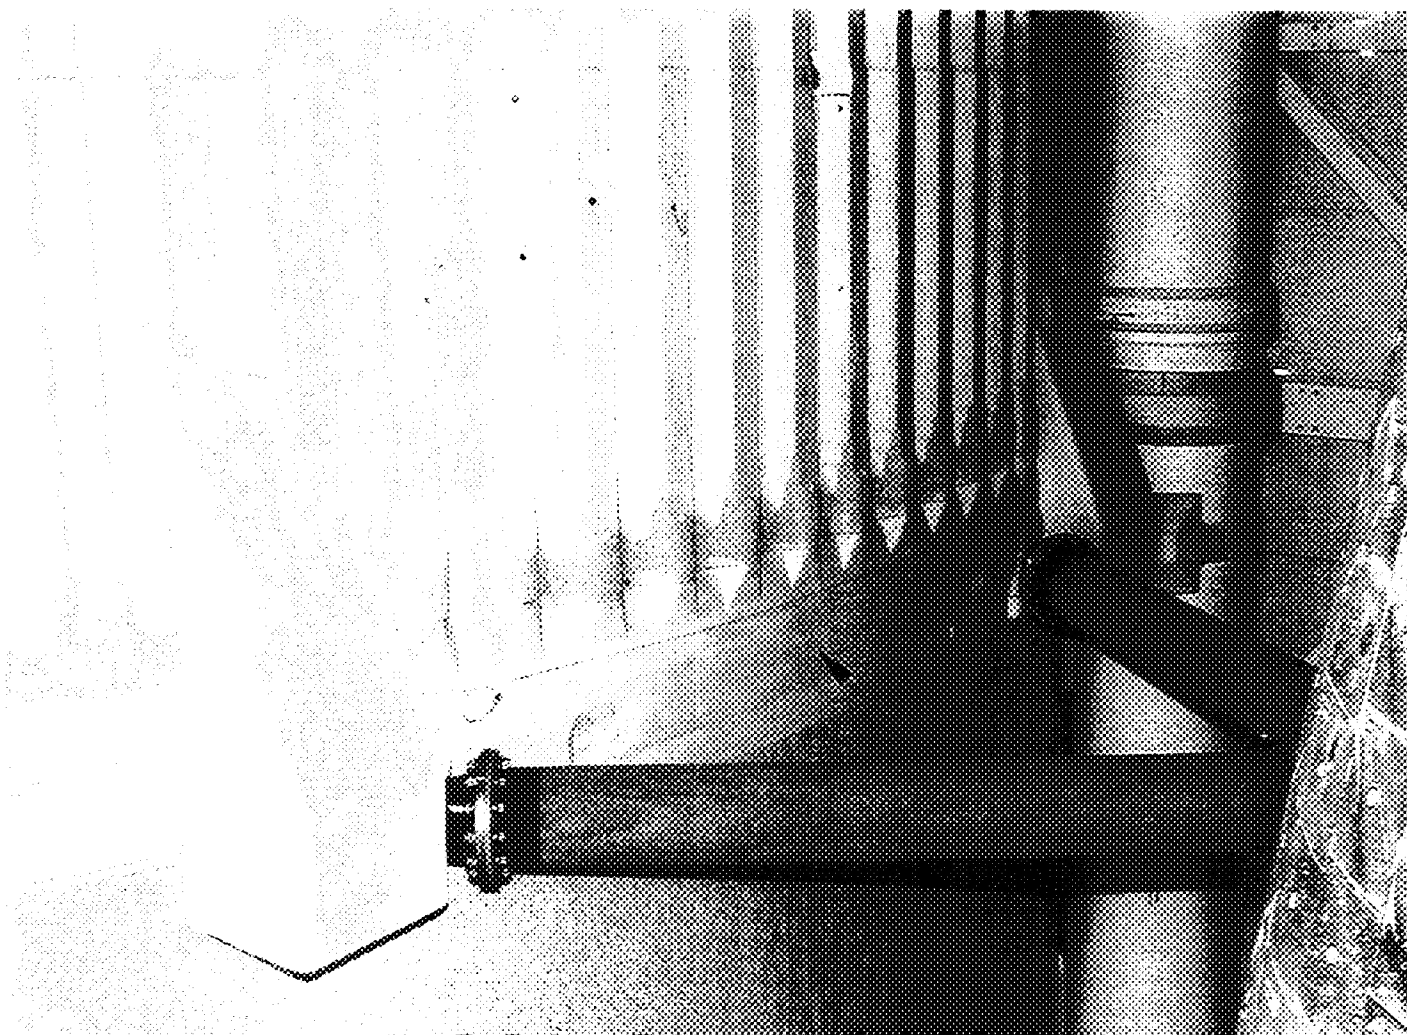
**Photo 16: Pre-Launch View of Flange Closeout**

A previously repaired area on the flange closeout near the ET centerline between the two bipods may have been associated with the divot detected in the on-orbit photography.

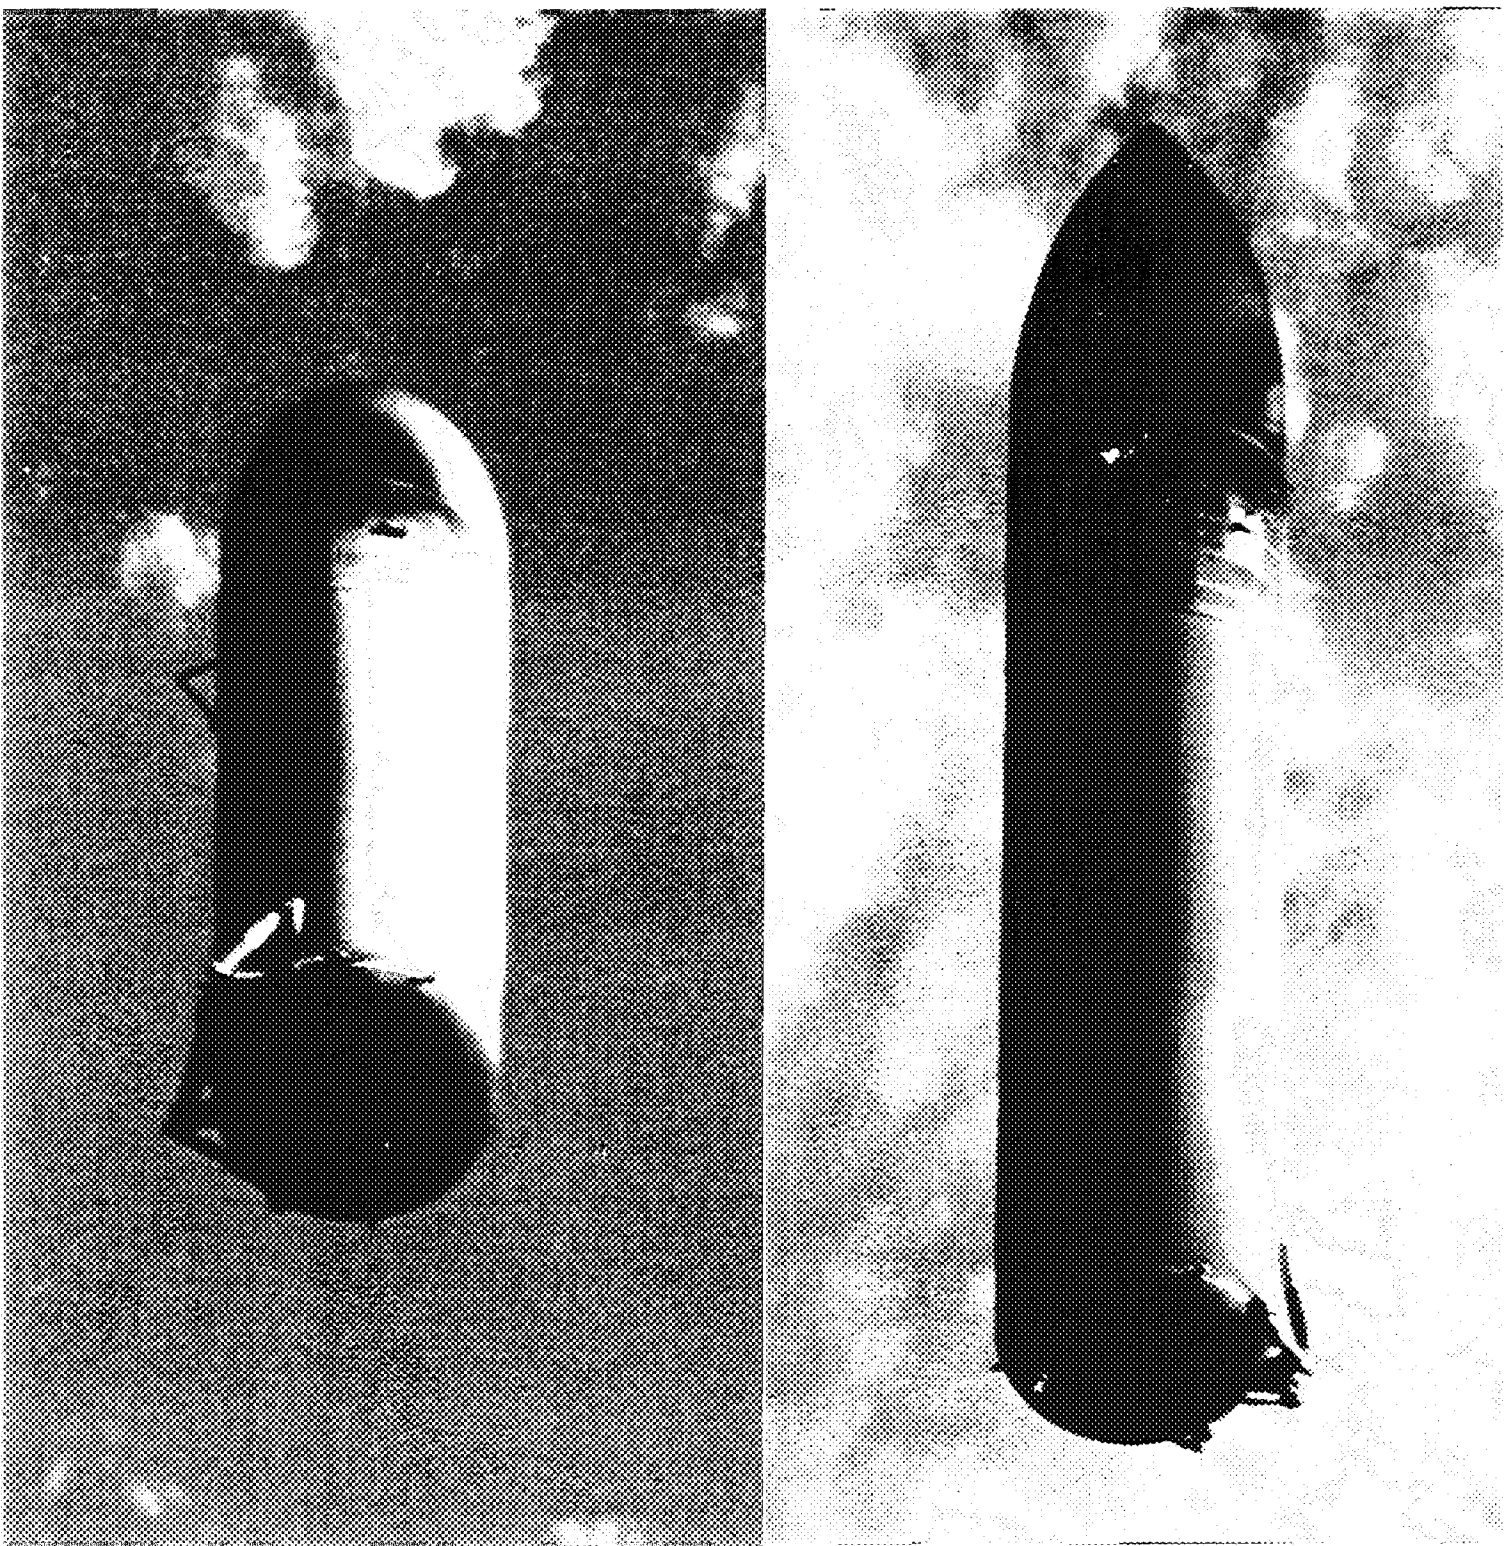
**Photo 17: Thrust Panels**

Loss of foam from both thrust panels that caused damage to Orbiter tiles is not readily apparent in this on-orbit photography. Small, circular, light-colored areas around the EB fittings and along the thrust panel-to-intertank splices may be divots. The BSM burn scars are typical.

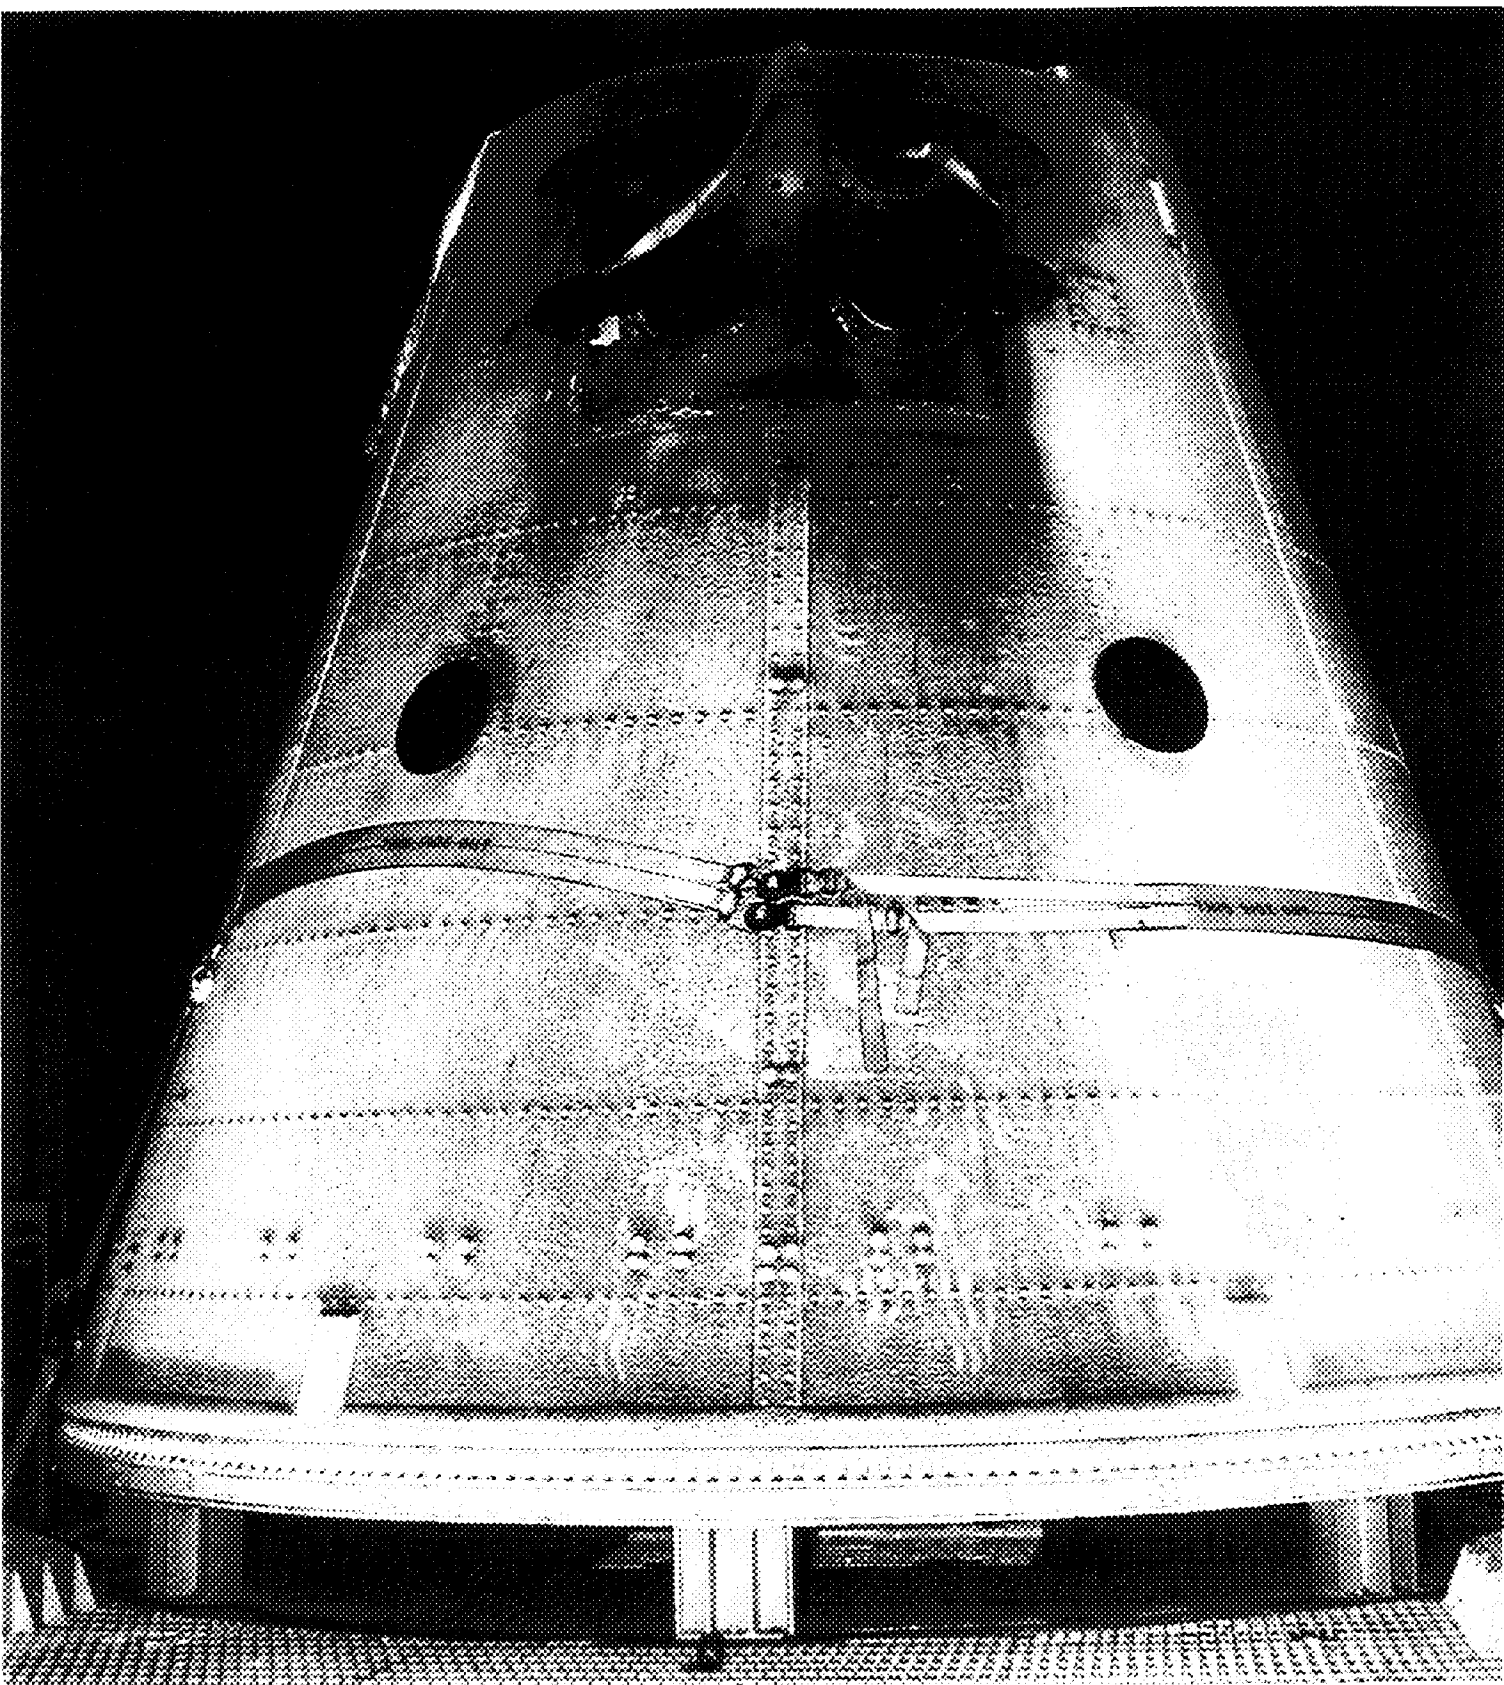
**Photo 18: Frustum Post Flight Condition**

Both frustums were in excellent condition. No TPS was missing and no debonds/unbonds were detected over fasteners or acreage. Virtually none of the Hypalon paint had blistered or peeled. All eight BSM aero heat shield covers had locked in the fully opened position.

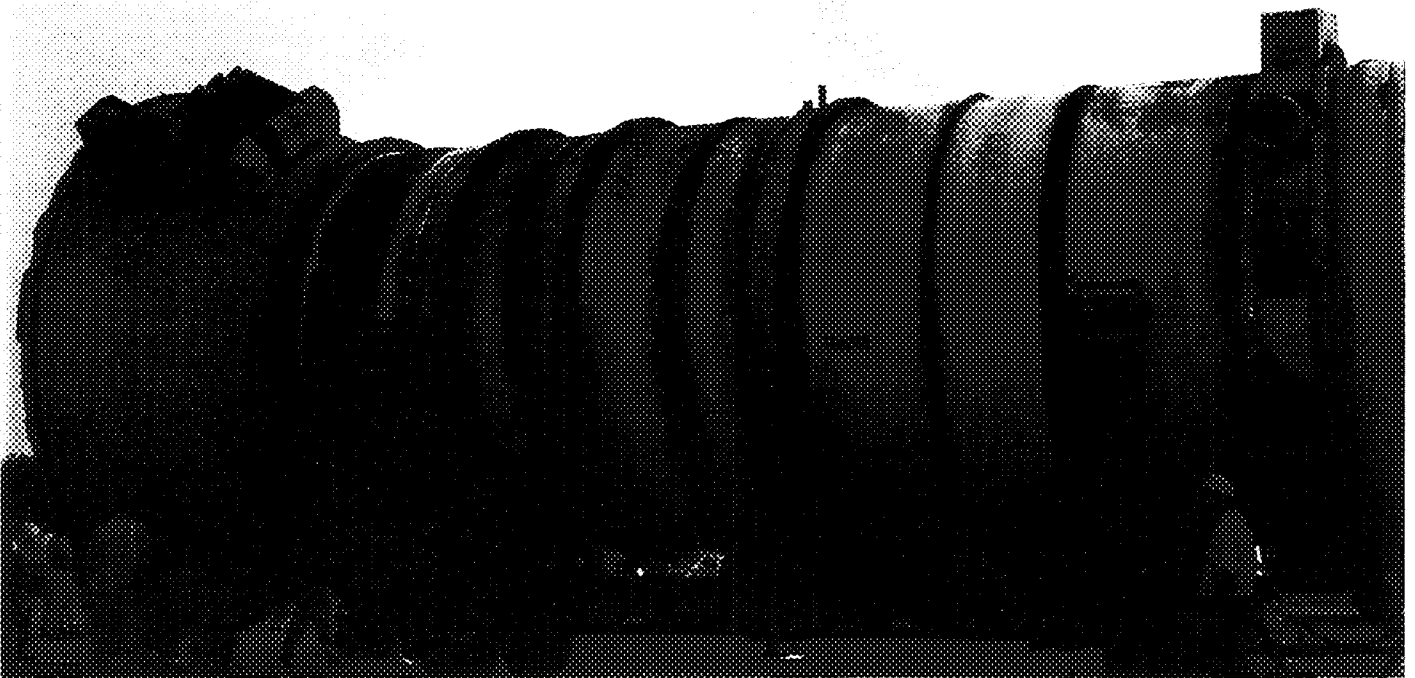
**Photo 20: Aft Booster/Aft Skirt Post Flight Condition**

The holddown post Debris Containment Systems (DCS) appeared to have functioned normally. However, the HDP #3 DCS plunger was completely obstructed by a frangible nut half and may have been the result of water impact. There was no stud hang-up on this launch. A bolt shank on the HDP #1 DCS cover was broken.

Separation of the aft ET/SRB struts appeared normal. TPS on the external surface of both aft skirts was intact and in good condition. The holddown post Debris Containment Systems (DCS) appeared to have functioned normally.

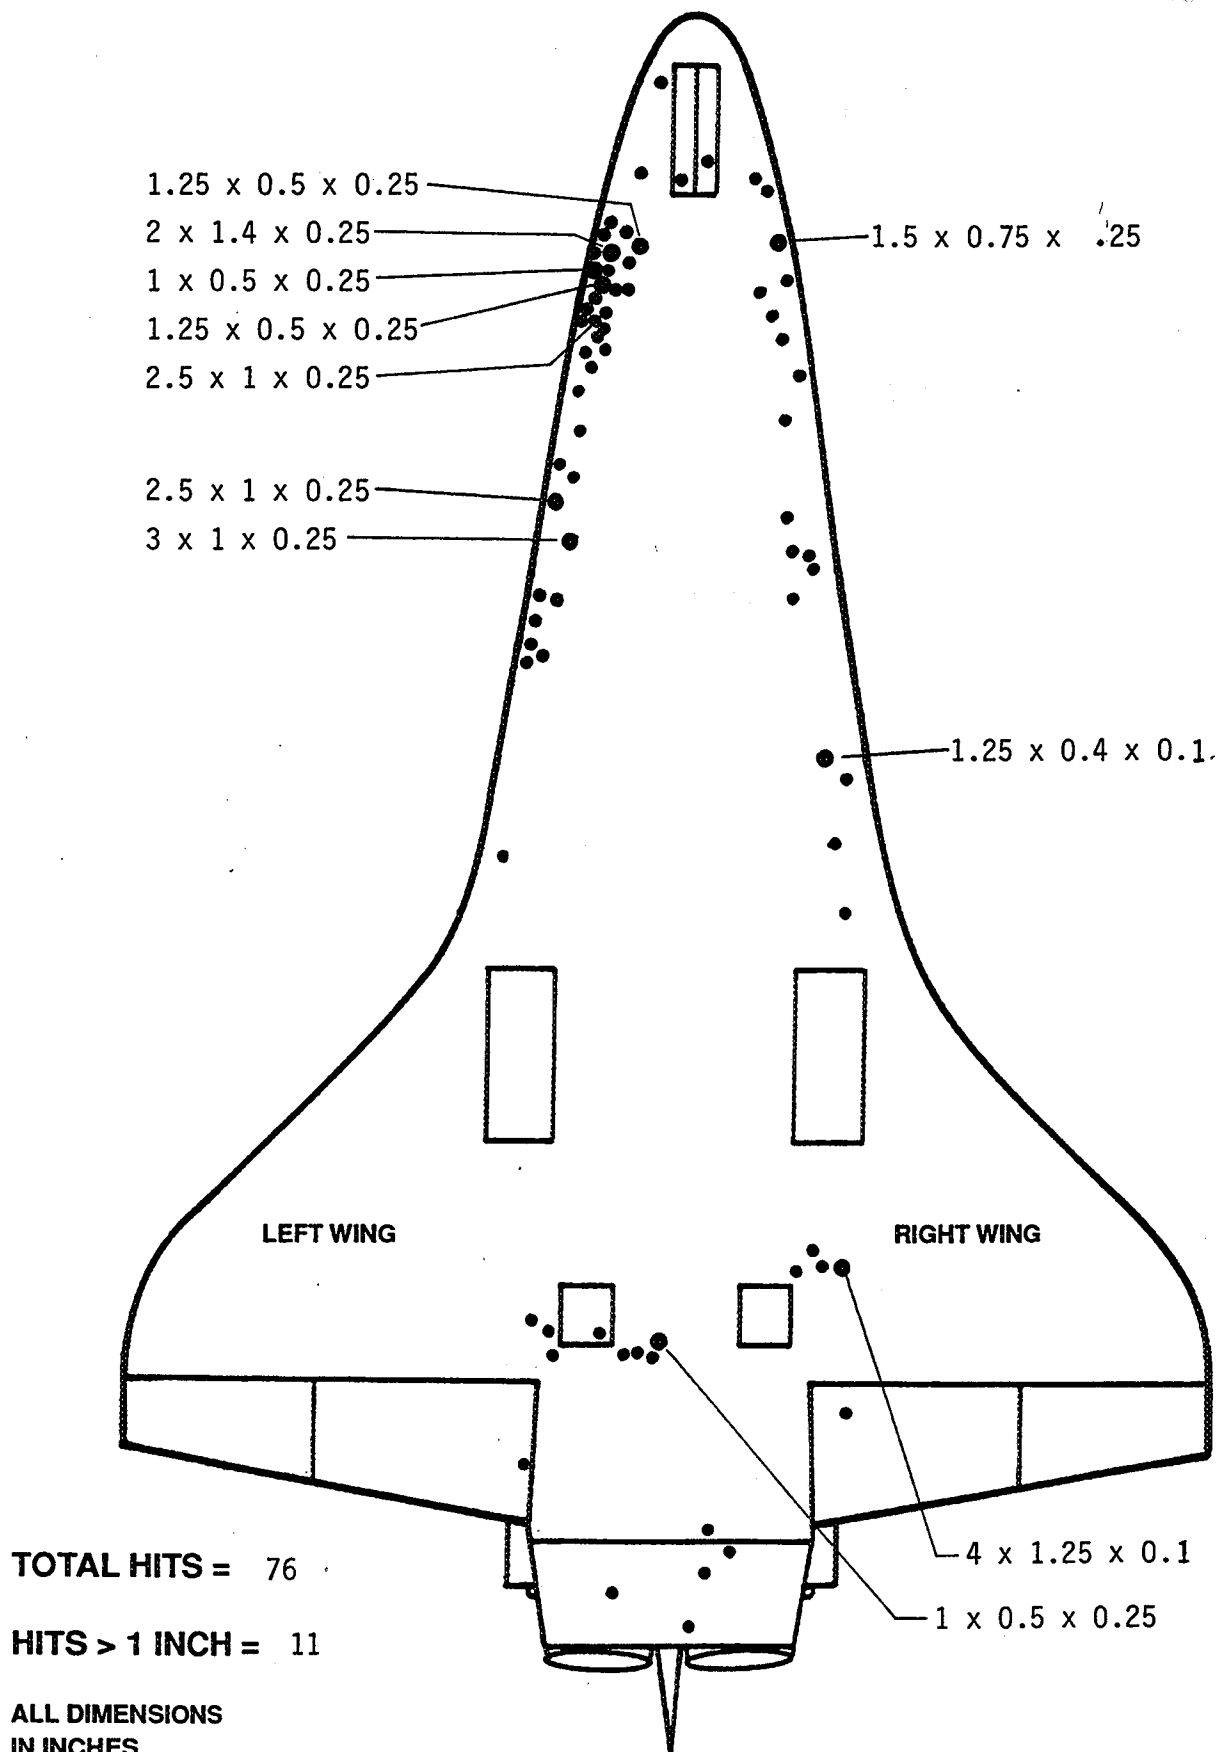
Figure 1: Orbiter Lower Surface Debris Damage Map

No lower surface tiles were scrapped due to debris damage. The deepest lower surface tile damage sites (0.25-inches) were located on the left chine and were most likely caused by loss of foam from the ET -Y thrust panel. The largest lower surface tile damage site was located aft of the RH main landing gear wheel well. The site measured 4-inches long by 1.25-inches wide by 0.1-inches deep and could have been caused by an impact from the umbilical purge barrier material or tape flapping in the airstream.

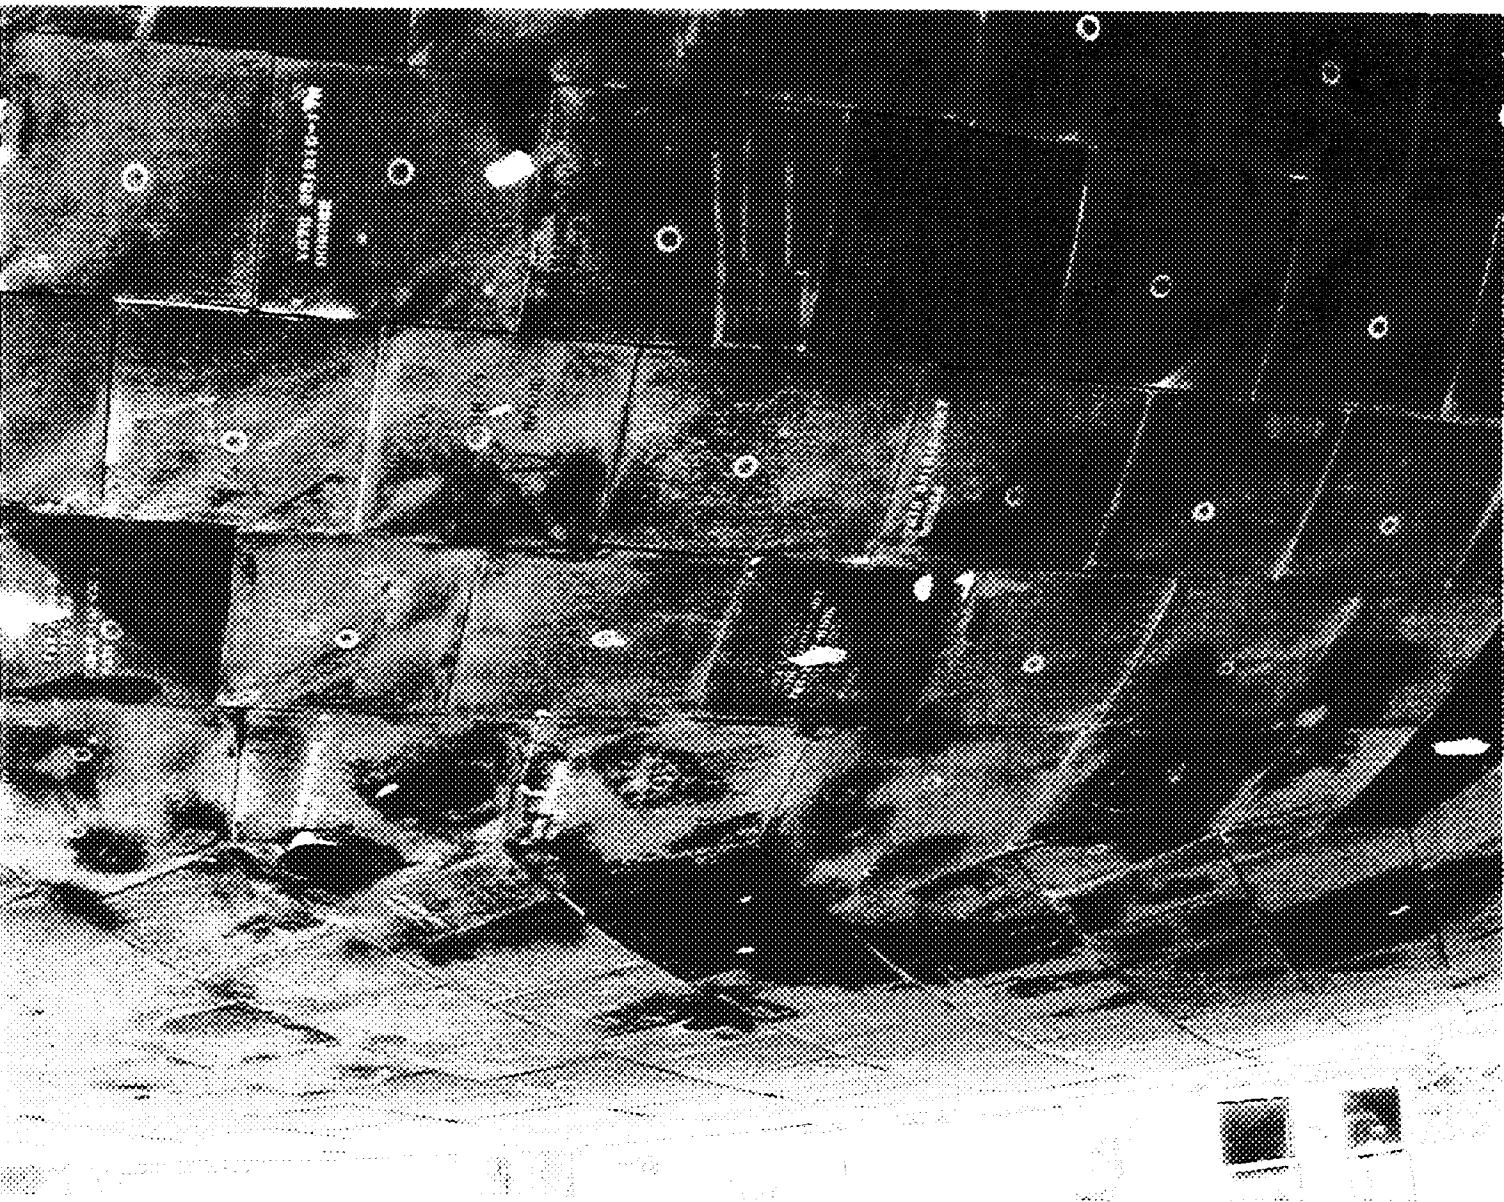
**Photo 23: Lower Surface Tile Damage**

The Orbiter lower surface sustained 76 total hits, of which 11 had a major dimension of 1-inch or larger. Most of this damage was concentrated aft of the nose to the main landing gear wheel wells on both left and right chines with most of the damage occurring on the left side. Virtually no damage occurred on the Orbiter centerline. These damage sites generally follow the same location pattern documented on STS-86, STS-87, and STS-89. The numbers are slightly less than the fleet averages for the lower surface (83 total hits with 13 larger than 1-inch) and can be attributed to the External Tank intertank foam being sanded to a greater degree than the previous tanks.
